# ETON America, LLC

## Service Bulletin

Bulletin No: 0016  
Date: 10/06/03

### Yukon (YXL-150) Flywheel Nut Coming Loose

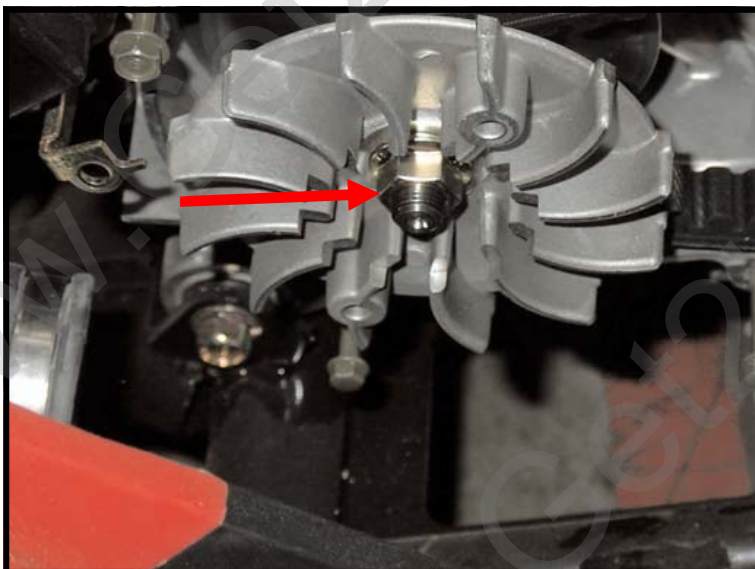
We have found in some cases that the flywheel nut is coming loose and causing severe internal damage, possibly damaging the crankshaft.

1. Remove left hand CVT cover to gain access to the flywheel assembly.
2. Remove Flywheel nut from crankshaft and **apply Blue locktight** to threads.
3. Re-Install Flywheel nut on crankshaft, torque value **85 ft/lbs**
4. Re-Install CVT Cover.
5. Road test unit to verify correction.
