ETON America, LLC

Service Bulletin

Bulletin No: 0035
Date: 06/14/2005

Viper 90R will not shift into neutral gear from forward or reverse.

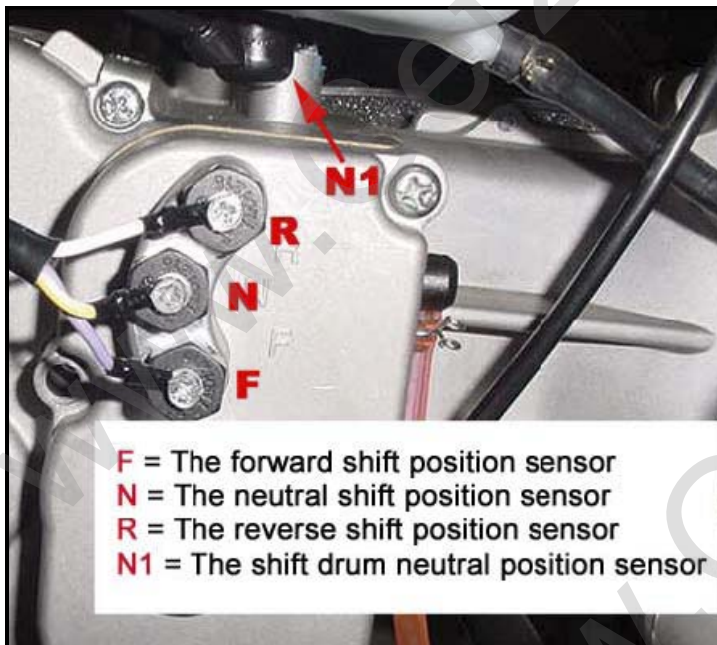
Transmission sensing unit

When shifting from forward to neutral or from reverse to neutral the shift motor does not turn. The N1 sensor is faulty. It is in an always on position sending the CDI the signal that the transmission is already in the neutral position.

To test the N1 sensor remove the lead from the N1 sensor and attach to the N sensor so that both the N and N1 sensor leads are now attached to the N sensor. Test shift the transmission from forward to neutral and again from reverse to neutral. If the transmission shift normally replace the N1 sensor.

Remove the faulty sensor and install a new sensor. Snug the new sensor into the seat until the seat just touches the transmission housing. **DO NOT** over tighten the sensor as over tightening can damage the sensor and cause the problem to be repeated.

Attach the N1 sensor lead to the new sensor and test shift the transmission for proper operation.
