ETON America, LLC

Service Bulletin

Bulletin No:	0048
Date:	12/08/06

UK1 Rover not shifting into gear properly

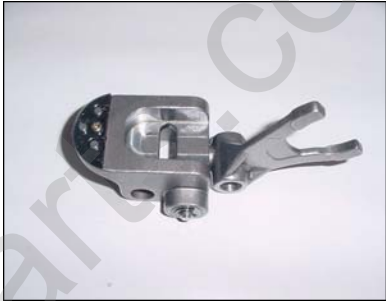
There is an engineering change affecting the 2007 Viper UK1 Rover 4 cycle utility cart. The Shift fork assembly has been reengineered to reduce friction, allowing the shift cogs to fully engage into reverse. Units with out this upgrade may display some or all of the following symptoms:

1. Incomplete shifting
2. Grinding noise from the gear box
3. Engine stalling during shifting
4. Blinking indicator lights

Qty	Part No.	Description
1	812741	Shift Fork Assembly

Labor Codes	
350	Replace the shift fork assembly
	Total time 1.0 hours
