Service Bulletin

Bulletin No: 0010
Date: 09/11/2000

Ground bolt replacement for Yukon 150

Yukon 150 (YXL-150)

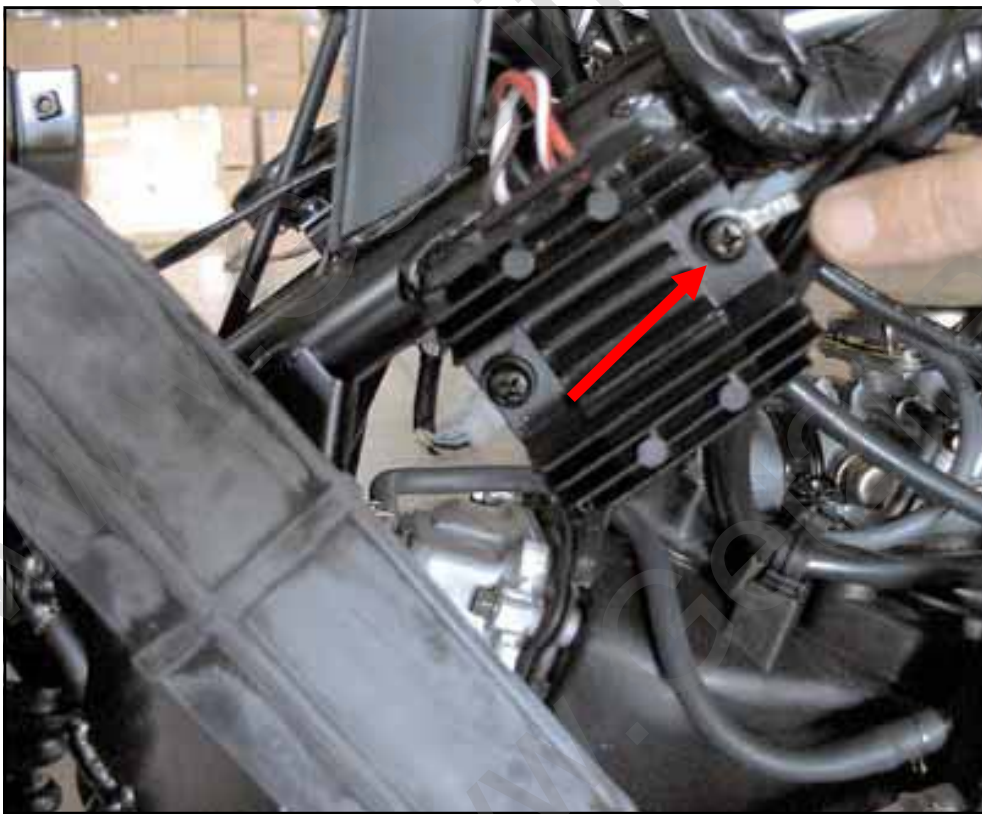
POOR GROUND AT REGULATOR

1. Remove grounding bolt, (see picture), clean contact surface on regulator and ground wire lead with sand paper. Replace grounding with a non-coated (M6 X 20) bolt & washer.
Test for good ground.
