Service Bulletin

0019
08/15/03

Fuel Line Routing for Improve Flow

Affecting all Viper 50 & Viper 90 model years 2002-2004.

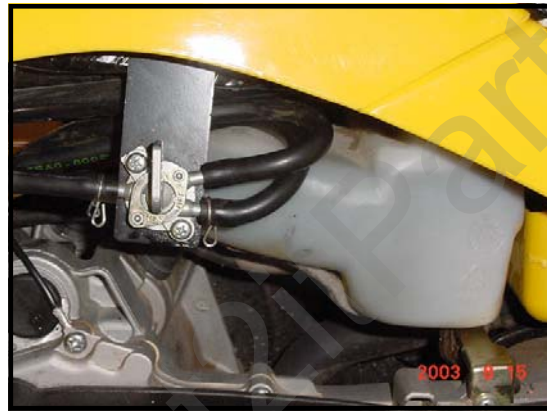
Fig #1

1. Being starved for fuel
2. You experience poor throttle response
3. You experience hesitation

Check your fuel line routing. If the fuel lines are routed as in fig #1 you may have a fuel flow restriction.
