ETON America, LLC

Service Bulletin

Bulletin No:	0036
Date:	01/06/06

RX4-90R Not shifting properly, shift motor making noise, or indicator lights blinking.

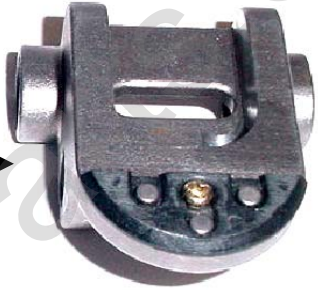
Qty	Part No.	Description
1	811674	Shift Push Assembly

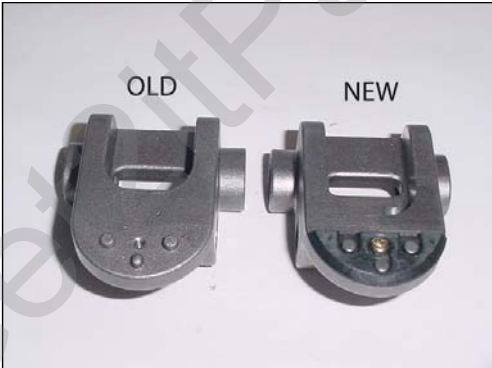
Step 15

The new shift push has a black insulator piece installed. Also, the length of the cam area is increased. This will allow less stress on the shift motor reduction gears.
