# ETON America, LLC

## Service Bulletin

Bulletin No: 0055  
Date: 07/21/2008

### Beamer blowing fuses when using the turn signals

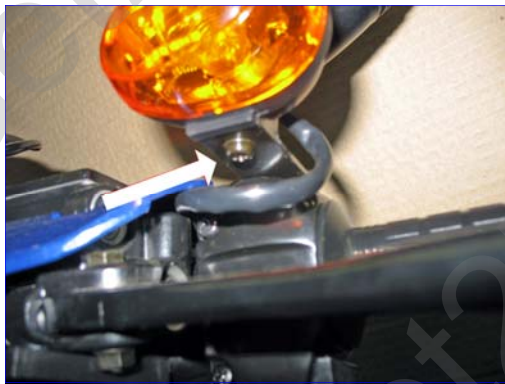
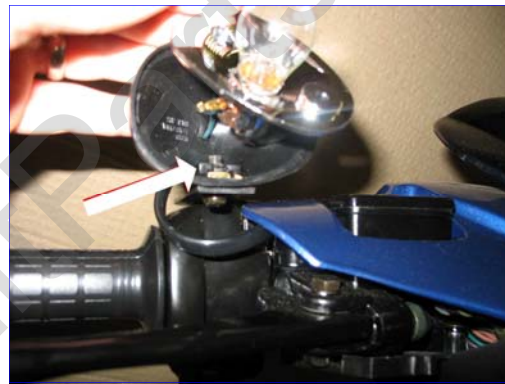
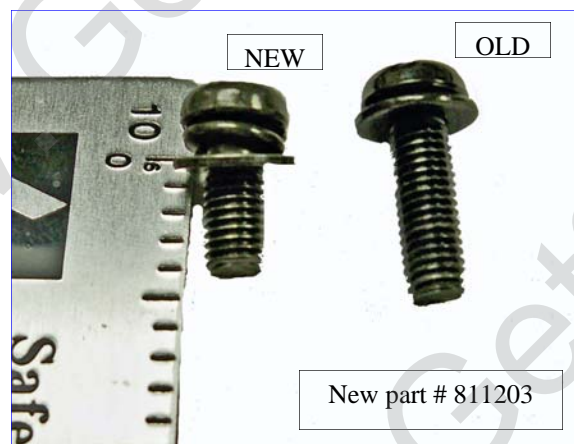
**PROBLEM:** All beamer and matrix 50 models in which the turn signals were moved above the handlebars will be affected. The Phillips head bolt that holds the turn signal to the top bracket is too long, and when tightened all the way down may touch the inside of the light bulb and cause a blown fuse when the turn signals are used.

**SOLUTION:** Order the new Part# 811203 quantity (2) and replace the LH and RH side to ensure proper operation. **If you have installed a windshield on your bike this bulletin will not apply. The turn signals will have to be moved below the handlebar assembly.**
