ETON America, LLC

Service Bulletin

Bulletin No: 0057
Date: 09/22/2008

2009 Matrix R4-150 & Matrix 50 models

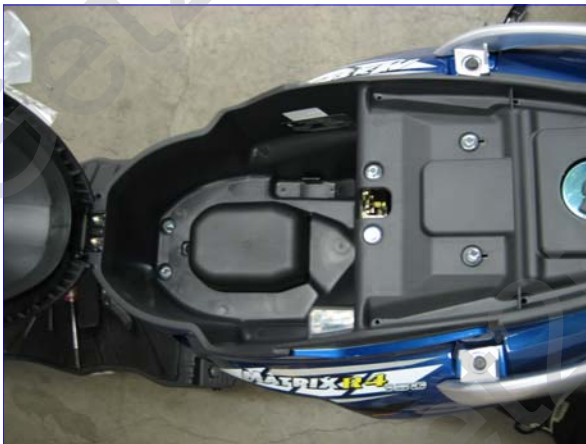
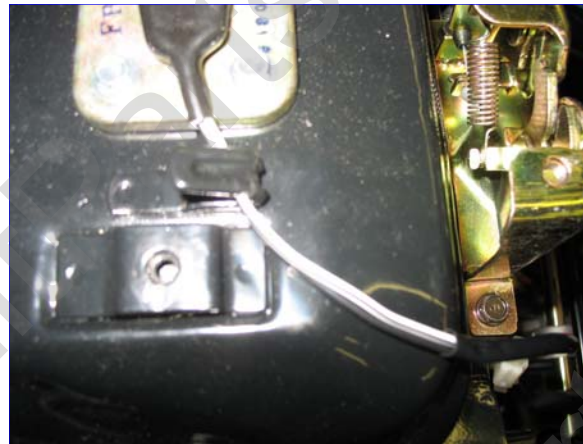
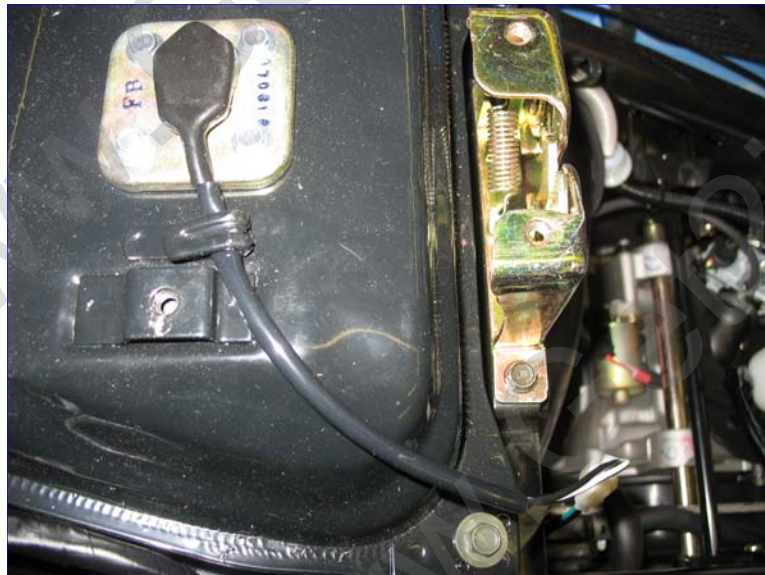
PROBLEM: On some units the fuel sending wires are not properly insulated when the clamp is closed and could cause a short in the wires to the harness.

SOULTION: Unlock the seat assembly remove the (6) bolts from the helmet box, then remove the helmet box from the body. Unclamp the sending unit wires and slide up the wire insulator and add electrical tape a each end to keep it from moving. Bend the clamp over the sending unit wires and rein-stall the helmet box.
