ETON America, LLC

Service Bulletin

Bulletin No: 0020
Date: 8/19/03

Wire Routing For Brake/Tail Lights

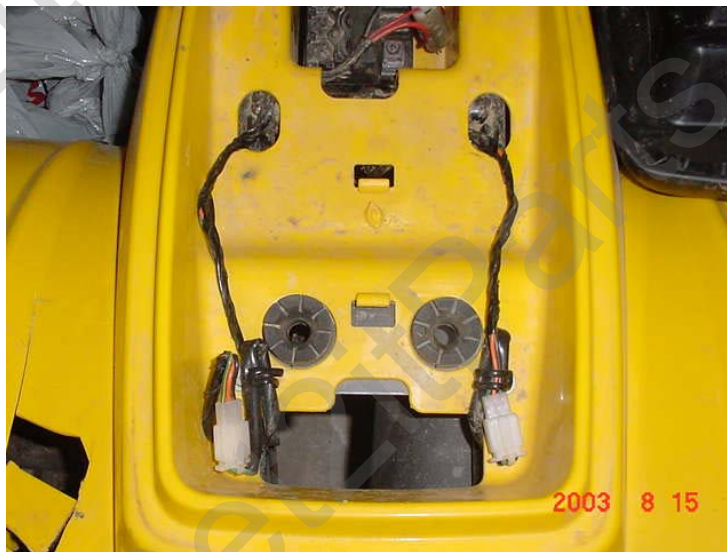
Figure 1

The rear tail light wires may have been routed where they are caught between seat supports and frame. This could cause a short in the harness or tail lights shown in figure 1. They should be routed behind the battery and pulled up through the plastic to connect to the rear tail lights as shown in Figure 2.
